RYDER HOME INSPECTIONS, LLC

[REDACTED]
[REDACTED]

06/19/2024

Lead-Based Paint Risk Assessment

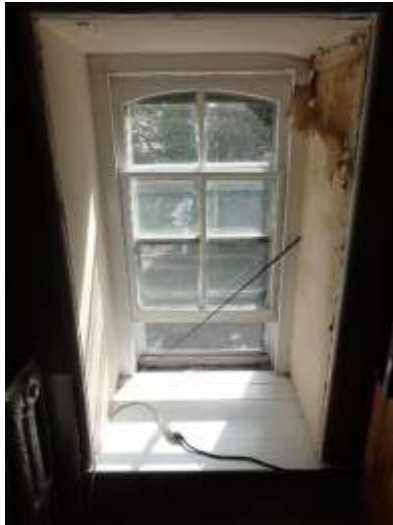
Shots # 7,8,9,10,13

XRF SUMMARY										
422 Locust Avenue Burlington NJ 08016										
READING #	FLOOR	WALL	ROOM/AREA	COMPONENT	SUBSTRATE	CONDITION	XRF RESULT	LEAD mg/cm ²	QTY	TREATMENT
7	3	A	Bedroom #4/ Window 1	Casing	Wood	Deteriorated	Positive	13.2	2	Stabilize and Encapsulate w/ 20 yr LBC
8	3	A	Bedroom #4/ Window 1	Stop	Wood	Deteriorated	Positive	10.8	2	Replace or Strip to Bare Substrate and Encapsulate w/ 20 yr LBC
9	3	A	Bedroom #4/ Window 1	Sash	Wood	Deteriorated	Positive	7.8	2	Replace Window
10	3	A	Bedroom #4/ Window 1	Sill	Wood	Deteriorated	Positive	11.9	2	Strip to Bare Substrate and Encapsulate w/ 20yr LBC
13	3	A	Bedroom #4/ Window 1	Header Casing	Wood	Deteriorated	Positive	11.8	2	Stabilize and Encapsulate w/ 20 yr LBC
14	3	A	3rd Fl Exterior	Cornice Bracket	Wood	Deteriorated	Positive	4.8	6	Stabilize and Encapsulate w/ 20 yr LBC
15	3	A	3rd Fl Exterior/ Window 2	Jamb	Wood	Deteriorated	Positive	33	4	Replace Window

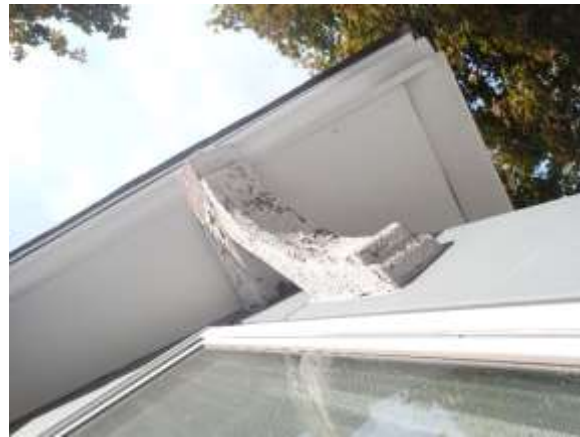
SHOT # 14

422 Locust Ave	13	11.8	mg/cm2	Positive	6/19/2024	Bedroom 4	Window 1	Header Casing	Wood	A	Deteriorated
422 Locust Ave	14	4.8	mg/cm2	Positive	6/19/2024	3rd Fl Exterior	Cornice Bracket		Wood	A	Deteriorated
422 Locust Ave	15	33	mg/cm2	Positive	6/19/2024	3rd Fl Exterior	Window 2	Jamb	Wood	A	Deteriorated
422 Locust Ave	16	27.1	mg/cm2	Positive	6/19/2024	3rd Fl Exterior	Window 2	Well	Metal	A	Deteriorated
422 Locust Ave	17	11.6	mg/cm2	Positive	6/19/2024	Bedroom 4	Room	Baseboard	Wood	C	Deteriorated
422 Locust Ave	18	11.9	mg/cm2	Positive	6/19/2024	Bedroom 4	Trim		Wood	B	Deteriorated
422 Locust Ave	19	0.3	mg/cm2	Negative	6/19/2024	Bedroom 4	Room	Wall	Wood	A	Deteriorated
422 Locust Ave	20	11.5	mg/cm2	Positive	6/19/2024	Bedroom 4	Door	Casing	Wood	C	Deteriorated
422 Locust Ave	21	9.8	mg/cm2	Positive	6/19/2024	Bedroom 4	Door	Jamb	Wood	C	Deteriorated
422 Locust Ave	22	11	mg/cm2	Positive	6/19/2024	Bedroom 4	Door	Stop	Wood	C	Deteriorated

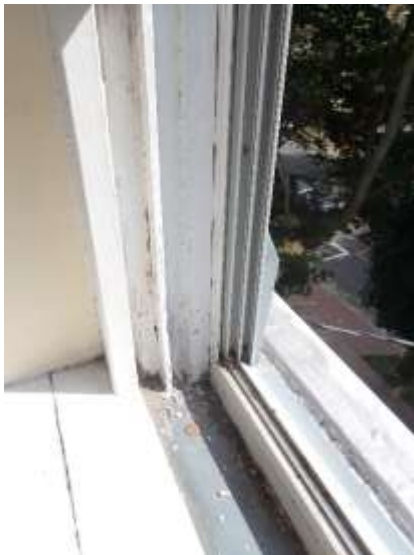
Shots # 15 & 16

16	3	A	3rd Fl Exterior/ Window 2	Well	Metal	Deteriorated	Positive	27.1	4	Replace Window
17	3	B	Bedroom #4	Baseboard	Wood	Deteriorated	Positive	11.6	1	Stabilize and Encapsulate w/ 20 yr LBC
18	3	B	Bedroom #4	Trim	Wood	Deteriorated	Positive	11.9	1	Strip to bare substrate and Encapsulate w/ 20 yr LBC
20	3	C	Bedroom #4/ Door	Casing	Wood	Deteriorated	Positive	11.5	2	Stabilize and Encapsulate w/ 20 yr LBC
21	3	C	Bedroom #4/ Door	Jamb	Wood	Deteriorated	Positive	9.8	2	Replace or Strip to Bare Substrate and Encapsulate w/ 20yr LBC
22	3	C	Bedroom #4/ Door	Stop	Wood	Deteriorated	Positive	11	2	Replace or Strip to Bare Substrate and Encapsulate w/ 20yr LBC
23	3	C	Bedroom #4/ Door	Door	Wood	Deteriorated	Positive	11.1	2	Replace or Strip to Bare Substrate and Encapsulate w/ 20 yr LBC
27	3	A	Bedroom #4/ Closet	Shelf Support	Wood	Deteriorated	Positive	12.5	1	Stabilize and Encapsulate w/ 20yr LBC
28	3	N/A	Bedroom #4/ Closet	Shelf	Wood	Deteriorated	Positive	1.4	1	Replace or Strip to Bare Substrate and Encapsulate w/ 20 yr LBC

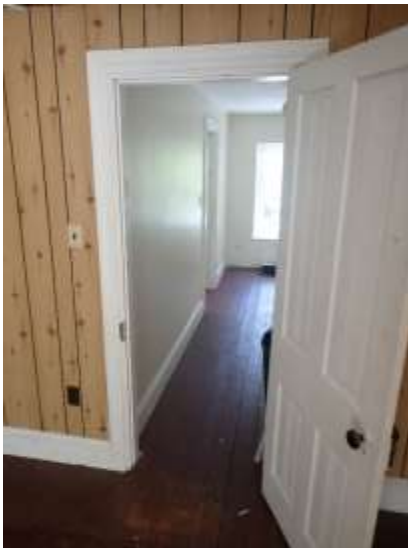
Shot # 23

422 Locust Ave	23	11.1	mg/cm2	Positive	6/19/2024	Bedroom 4	Door		Wood	C	Deteriorated
422 Locust Ave	24	0	mg/cm2	Negative	6/19/2024	Bedroom 4	Closet	Wall	Plaster	A	Deteriorated
422 Locust Ave	25	0.1	mg/cm2	Negative	6/19/2024	Bedroom 4	Closet	Wall	Drywall	B	Deteriorated
422 Locust Ave	26	0	mg/cm2	Negative	6/19/2024	Bedroom 4	Closet	Wall	Drywall	C	Deteriorated
422 Locust Ave	27	12.5	mg/cm2	Positive	6/19/2024	Bedroom 4	Closet	Shelf Support	Wood	A	Deteriorated
422 Locust Ave	28	1.4	mg/cm2	Positive	6/19/2024	Bedroom 4	Closet	Shelf	Wood		Deteriorated
422 Locust Ave	29	0	mg/cm2	Negative	6/19/2024	Bedroom 4	Room	Floor	Wood		Deteriorated
422 Locust Ave	30	0.4	mg/cm2	Negative	6/19/2024	Bedroom 4	Radiator		Metal	A	Deteriorated
422 Locust Ave	31	0	mg/cm2	Negative	6/19/2024	Bedroom 5	Room	Wall	Plaster	A	Deteriorated
422 Locust Ave	32	0.3	mg/cm2	Negative	6/19/2024	Bedroom 5	Room	Wall	Plaster	B	Deteriorated
422 Locust Ave	33	0.2	mg/cm2	Negative	6/19/2024	Bedroom 5	Room	Wall	Plaster	C	Deteriorated

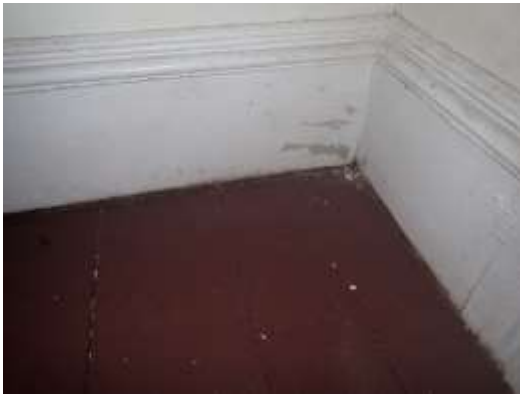
Shot # 36

36	3	A	Bedroom #5	Baseboard	Wood	Deteriorated	Positive	10.1	1	Replace or Strip to Bare Substrate and Encapsulate w/ 20 yr LBC
37	3	D	Bedroom #5/ Door	Casing	Wood	Deteriorated	Positive	11.1	2	Stabilize and Encapsulate w/ 20 yr LBC
38	3	D	Bedroom #5/ Door	Jamb	Wood	Deteriorated	Positive	12.1	2	Strip to Bare Substrate and Encapsulate w/ 20yr LBC
39	3	D	Bedroom #5/ Door	Stop	Wood	Deteriorated	Positive	9.7	2	Replace or Strip to Bare Substrate and Encapsulate w/ 20yr LBC

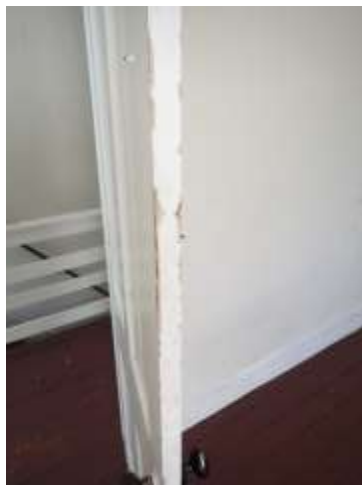
Shot # 40

XRF SUMMARY										
422 Locust Avenue Burlington NJ 08016										
READING #	FLOOR	WALL	ROOM/AREA	COMPONENT	SUBSTRATE	CONDITION	XRF RESULT	LEAD mg/cm ²	QTY	TREATMENT
40	3	D	Bedroom #5	Door	Wood	Deteriorated	Positive	9.4	2	Replace or Strip to Bare Substrate and Encapsulate w/ 20yr LBC
41	3	B	Bedroom #5/ Window	Casing	Wood	Deteriorated	Positive	8.3	1	Stabilize and Encapsulate w/ 20 yr LBC
42	3	B	Bedroom #5/ Window	Casing	Wood	Deteriorated	Positive	8.8	1	Stabilize and Encapsulate w/ 20 yr LBC
43	3	B	Bedroom #5/ Window	Stop	Wood	Deteriorated	Positive	2.7	1	Replace or Strip to Bare Substrate and Encapsulate w/ 20 yr LBC
44	3	B	Bedroom #5/ Window	Sill	Wood	Deteriorated	Positive	6.6	1	Strip To Bare Substrate and Encapsulate w/ 20 yr LBC
45	3	B	Bedroom #5/ Window	Apron	Wood	Deteriorated	Positive	10.9	1	Stabilize and Encapsulate w/ 20 yr LBC
50	3	A	Bedroom #5/ Closet	Shelf Support	Wood	Deteriorated	Positive	10	1	Stabilize and Encapsulate w/ 20 yr LBC

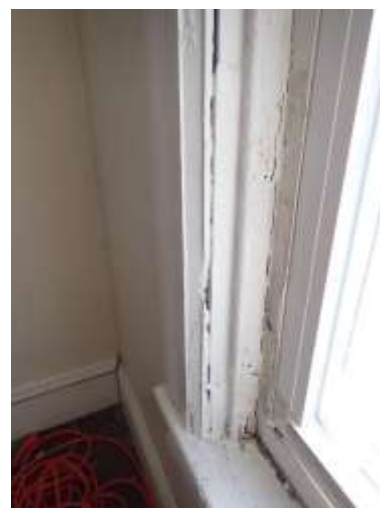
Shots #41,42,43,44,45

422 Locust Ave	34	0	mg/cm2	Negative	6/19/2024	Bedroom 5	Room	Wall	Plaster	D	Deteriorated
422 Locust Ave	35	0	mg/cm2	Negative	6/19/2024	Bedroom 5	Room	Ceiling	Drywall		Deteriorated
422 Locust Ave	36	10.1	mg/cm2	Positive	6/19/2024	Bedroom 5	Room	Baseboard	Wood	A	Deteriorated
422 Locust Ave	37	11.1	mg/cm2	Positive	6/19/2024	Bedroom 5	Door	Casing	Wood	D	Deteriorated
422 Locust Ave	38	12.1	mg/cm2	Positive	6/19/2024	Bedroom 5	Door	Jamb	Wood	D	Deteriorated
422 Locust Ave	39	9.7	mg/cm2	Positive	6/19/2024	Bedroom 5	Door	Stop	Wood	D	Deteriorated
422 Locust Ave	40	9.4	mg/cm2	Positive	6/19/2024	Bedroom 5	Door		Wood	D	Deteriorated
422 Locust Ave	41	8.3	mg/cm2	Positive	6/19/2024	Bedroom 5	Window	Casing	Wood	B	Deteriorated
422 Locust Ave	42	8.8	mg/cm2	Positive	6/19/2024	Bedroom 5	Window	Casing	Wood	B	Deteriorated
422 Locust Ave	43	2.7	mg/cm2	Positive	6/19/2024	Bedroom 5	Window	Stop	Wood	B	Deteriorated
422 Locust Ave	44	6.6	mg/cm2	Positive	6/19/2024	Bedroom 5	Window	Sill	Wood	B	Deteriorated

422 Locust Ave	45	10.9	mg/cm2	Positive	6/19/2024	Bedroom 5	Window	Apron	Wood	B	Deteriorated
422 Locust Ave	46	0	mg/cm2	Negative	6/19/2024	Bedroom 5	Closet	Wall	Plaster	A	Deteriorated
422 Locust Ave	47	0.1	mg/cm2	Negative	6/19/2024	Bedroom 5	Closet	Wall	Drywall	B	Deteriorated
422 Locust Ave	48	0.3	mg/cm2	Negative	6/19/2024	Bedroom 5	Closet	Wall	Drywall	C	Deteriorated
422 Locust Ave	49	0.2	mg/cm2	Negative	6/19/2024	Bedroom 5	Closet	Wall	Plaster	D	Deteriorated
422 Locust Ave	50	10	mg/cm2	Positive	6/19/2024	Bedroom 5	Closet	Shelf Support	Wood	A	Deteriorated
422 Locust Ave	51	0.1	mg/cm2	Negative	6/19/2024	Bedroom 5	Closet	Shelf	Wood		Deteriorated
422 Locust Ave	52	0.1	mg/cm2	Negative	6/19/2024	Bedroom 5	Room	Floor	Wood		Deteriorated
422 Locust Ave	53	0.8	mg/cm2	Negative	6/19/2024	Bedroom 5	Radiator		Metal		Deteriorated

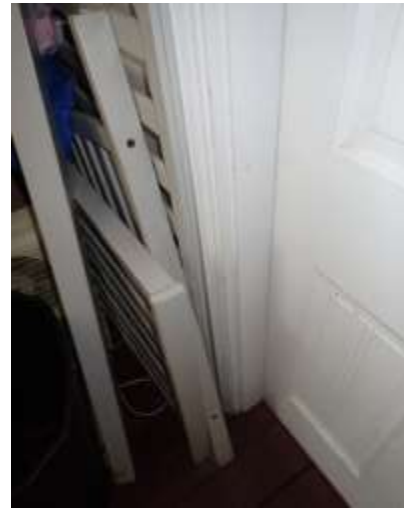
Shots # 59,60,61

59	3	A	Hallway 3/ Door	Casing	Wood	Deteriorated	Positive	11.8	2	Stabilize and Encapsulate w/ 20 yr LBC
60	3	A	Hallway 3/ Door	Inner Casing	Wood	Deteriorated	Positive	13.5	2	Stabilize and Encapsulate w/ 20 yr LBC
61	3	A	Hallway 3	Door	Wood	Deteriorated	Positive	11.1	2	Replace or Strip to Bare Substrate and Encapsulate w/ 20 yr LBC
62	3	N/A	Hallway 3	Railing	Wood	Deteriorated	Positive	10.1	1	Replace or Strip to Bare Substrate and Encapsulate w/ 20 yr LBC
63	3	B	Hallway 3	Baseboard	Wood	Deteriorated	Positive	13	1	Stabilize and Encapsulate w/ 20 yr LBC
65	3	C	Hallway 3/ Window	Casing	Wood	Deteriorated	Positive	14.2	1	Stabilize and Encapsulate w/ 20 yr LBC
66	3	C	Hallway 3/ Window	Stop	Wood	Deteriorated	Positive	12.2	1	Replace or Strip to Bare Substrate and Encapsulate w/ 20 yr LBC
67	3	C	Hallway 3/ Window	Sill	Wood	Deteriorated	Positive	8	1	Strip to Bare Substrate and Encapsulate w/ 20 yr LBC
68	3	C	Hallway 3	Trim	Wood	Deteriorated	Positive	12.4	1	Strip to Bare Substrate and Encapsulate w/20 yr LBC

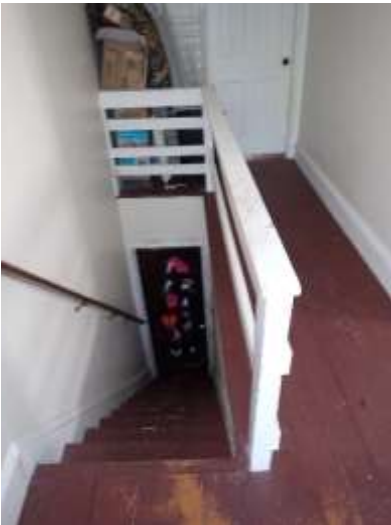
Shot #62

JOB ID:	READING #:	CONCENTRATION:	UNITS:	RESULT:	DATE:	ROOM:	STRUCTURE:	COMPONENT:	SUBSTRATE:	SIDE:	CONDITION:
422 Locust Ave	54	0	mg/cm2	Negative	6/19/2024	Hallway 3	Room	Wall	Plaster	A	Deteriorated
422 Locust Ave	55	0	mg/cm2	Negative	6/19/2024	Hallway 3	Room	Wall	Plaster	B	Deteriorated
422 Locust Ave	56	0	mg/cm2	Negative	6/19/2024	Hallway 3	Room	Wall	Drywall	C	Deteriorated
422 Locust Ave	57	0	mg/cm2	Negative	6/19/2024	Hallway 3	Room	Wall	Drywall	D	Deteriorated
422 Locust Ave	58	0.2	mg/cm2	Negative	6/19/2024	Hallway 3	Room	Ceiling	Drywall		Deteriorated
422 Locust Ave	59	11.8	mg/cm2	Positive	6/19/2024	Hallway 3	Door	Casing	Wood	A	Deteriorated
422 Locust Ave	60	13.5	mg/cm2	Positive	6/19/2024	Hallway 3	Door	Inner Casing	Wood	A	Deteriorated
422 Locust Ave	61	11.1	mg/cm2	Positive	6/19/2024	Hallway 3	Door		Wood	A	Deteriorated
422 Locust Ave	62	10.1	mg/cm2	Positive	6/19/2024	Hallway 3	Stair	Railing	Wood		Deteriorated

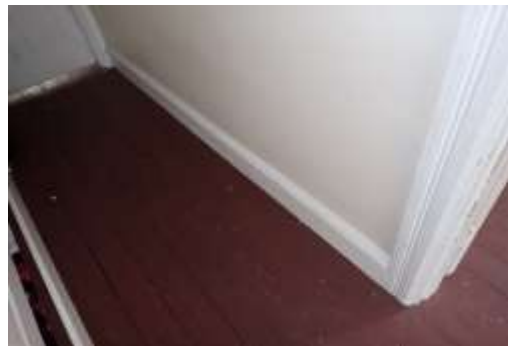
Shot # 63

422 Locust Ave	63	13	mg/cm2	Positive	6/19/2024	Hallway 3	Room	Baseboard	Wood	B	Deteriorated
422 Locust Ave	64	0.1	mg/cm2	Negative	6/19/2024	Hallway 3	Room	Floor	Wood		Deteriorated
422 Locust Ave	65	14.2	mg/cm2	Positive	6/19/2024	Hallway 3	Window	Casing	Wood	C	Deteriorated
422 Locust Ave	66	12.2	mg/cm2	Positive	6/19/2024	Hallway 3	Window	Stop	Wood	C	Deteriorated
422 Locust Ave	67	8	mg/cm2	Positive	6/19/2024	Hallway 3	Window	Sill	Wood	C	Deteriorated
422 Locust Ave	68	12.4	mg/cm2	Positive	6/19/2024	Hallway 3	Trim		Wood	C	Deteriorated
422 Locust Ave	69	7.3	mg/cm2	Positive	6/19/2024	Stairwell 2	Door	Casing	Wood	A	Deteriorated
422 Locust Ave	70	8.3	mg/cm2	Positive	6/19/2024	Stairwell 2	Door	Inner Casing	Wood	A	Deteriorated
422 Locust Ave	71	0	mg/cm2	Negative	6/19/2024	Stairwell 2	Door	Stop	Wood	A	Deteriorated
422 Locust Ave	72	0	mg/cm2	Negative	6/19/2024	Stairwell 2	Door		Wood	A	Deteriorated
422 Locust Ave	73	0.1	mg/cm2	Negative	6/19/2024	Stairwell 2	Stair	Risers	Wood	C	Deteriorated

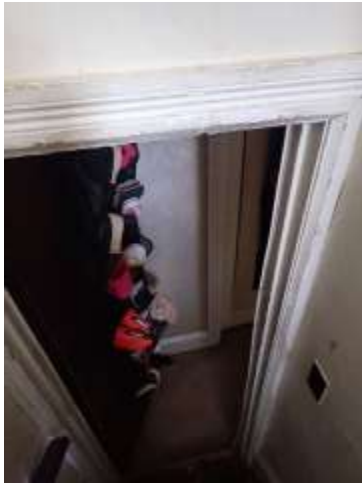
Shots # 69,70

69	2	A	Stairwell 2/ Door	Casing	Wood	Deteriorated	Positive	7.3	1	Stabilize and Encapsulate w/ 20 yr LBC

XRF SUMMARY										
422 Locust Avenue Burlington NJ 08016										
READING #	FLOOR	WALL	ROOM/AREA	COMPONENT	SUBSTRATE	CONDITION	XRF RESULT	LEAD mg/cm ²	QTY	TREATMENT
70	2	A	Stairwell 2/ Door	Inner Casing	Wood	Deteriorated	Positive	8.3	1	Stabilize and Encapsulate w/ 20 yr LBC
75	2	B	Stairwell 2	Stringer	Wood	Deteriorated	Positive	8.6	1	Strip to Bare Substrate and Encapsulate w/ 20 yr LBC
88	1	A	Living Room/ Window 1	Sash	Wood	Deteriorated	Positive	1.3	2	Replace Window
105	1	A	Office/ Window	Sash	Wood	Deteriorated	Positive	1.2	4	Replace Window
106	1	A	Office/ Window	Exterior Jamb	Wood	Deteriorated	Positive	38	4	Replace Window
109	1	C	Office/ Door	Threshold	Wood	Deteriorated	Positive	2.8	1	Strip to Bare Substrate and Encapsulate w/ 20 yr LBC
110	1	C	Office/ Door	Exterior Jamb	Wood	Deteriorated	Positive	34	1	Strip to Bare Substrate and Encapsulate w/ 20 yr LBC
126	1	D	Dining Room/ Window 1	Exterior Sill	Wood	Deteriorated	Positive	12.8	4	Replace or Strip to Bare Substrate and Encapsulate w/ 20 yr LBC

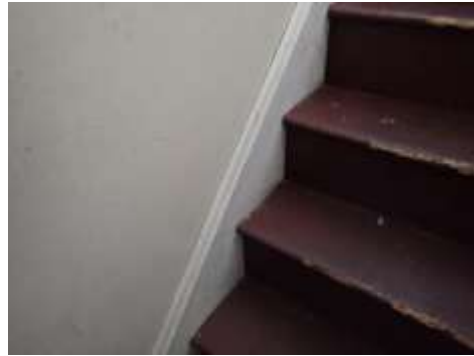
Shot # 75

422 Locust Ave	74	0.1	mg/cm2	Negative	6/19/2024	Stairwell 2	Stair	Treads	Wood	C	Deteriorated
422 Locust Ave	75	8.6	mg/cm2	Positive	6/19/2024	Stairwell 2	Stair	Stringer	Wood	B	Deteriorated
422 Locust Ave	76	0	mg/cm2	Negative	6/19/2024	Stairwell 2	Stair	Railing	Wood	D	Deteriorated
422 Locust Ave	77	0.2	mg/cm2	Negative	6/19/2024	Front Foyer	Door	Casing	Wood	C	Deteriorated
422 Locust Ave	78	0.2	mg/cm2	Negative	6/19/2024	Front Foyer	Door	Inner Casing	Wood	C	Deteriorated
422 Locust Ave	79	0	mg/cm2	Negative	6/19/2024	Front Foyer	Door	Stop	Wood	C	Deteriorated
422 Locust Ave	80	0.1	mg/cm2	Negative	6/19/2024	Front Foyer	Door		Wood	C	Deteriorated
422 Locust Ave	81	0	mg/cm2	Negative	6/19/2024	Front Foyer	Door	Threshold	Wood	C	Deteriorated
422 Locust Ave	82	0.1	mg/cm2	Negative	6/19/2024	Front Foyer	Room	Floor	Wood		Deteriorated
422 Locust Ave	83	0.2	mg/cm2	Negative	6/19/2024	Front Foyer	Room	Wall	Wood	C	Deteriorated

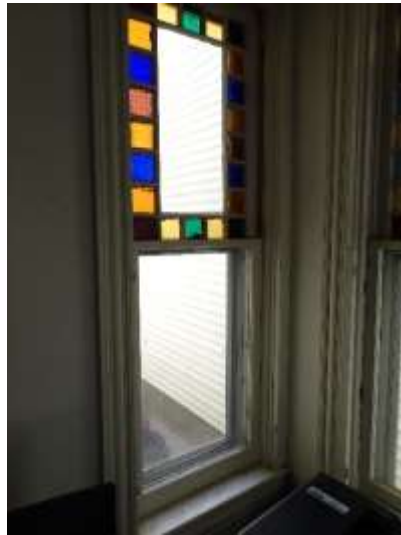
Shot # 105

422 Locust Ave	104	0.4	mg/cm2	Negative	6/19/2024	Office	Window	Apron	Wood	A	Deteriorated
422 Locust Ave	105	1.2	mg/cm2	Positive	6/19/2024	Office	Window	Sash	Wood	A	Deteriorated

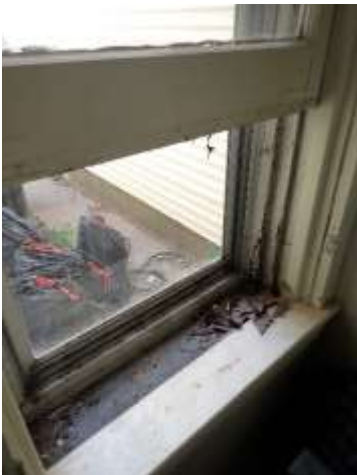
Shot #
106

JOB ID:	READING #:	CONCENTRATION:	UNITS:	RESULT:	DATE:	ROOM:	STRUCTURE:	COMPONENT:	SUBSTRATE:	SIDE:	CONDITION:
422 Locust Ave	106	38	mg/cm2	Positive	6/19/2024	Office	Window	Exterior Jamb	Wood	A	Deteriorated
422 Locust Ave	107	0.1	mg/cm2	Negative	6/19/2024	Office	Door	Casing	Wood	A	Deteriorated
422 Locust Ave	108	0.1	mg/cm2	Negative	6/19/2024	Office	Door	Jamb	Wood	A	Deteriorated
422 Locust Ave	109	2.8	mg/cm2	Positive	6/19/2024	Office	Door	Threshold	Wood	C	Deteriorated
422 Locust Ave	110	34	mg/cm2	Positive	6/19/2024	Office	Door	Exterior Jamb	Wood	C	Deteriorated
422 Locust Ave	111	0	mg/cm2	Negative	6/19/2024	Office	Door		Wood	A	Deteriorated
422 Locust Ave	112	0	mg/cm2	Negative	6/19/2024	Dining Room	Room	Wall	Drywall	A	Deteriorated
422 Locust Ave	113	0	mg/cm2	Negative	6/19/2024	Dining Room	Room	Wall	Drywall	B	Deteriorated
422 Locust Ave	114	0.1	mg/cm2	Negative	6/19/2024	Dining Room	Room	Wall	Drywall	C	Deteriorated

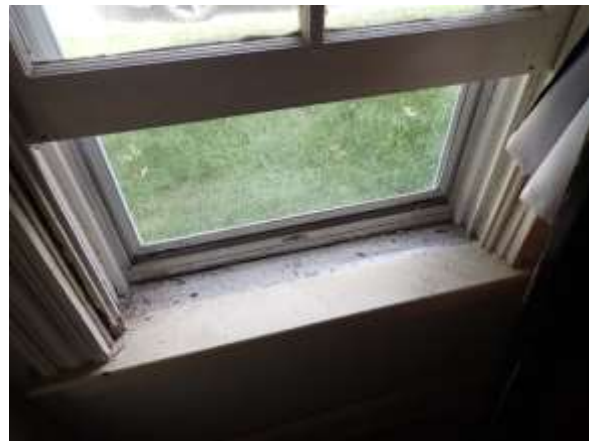
Shot #126

422 Locust Ave	125	0.2	mg/cm2	Negative	6/19/2024	Dining Room	Window 1	Sash	Wood	D	Deteriorated
422 Locust Ave	126	12.8	mg/cm2	Positive	6/19/2024	Dining Room	Window 1	Exterior Sill	Wood	D	Deteriorated
422 Locust Ave	127	32	mg/cm2	Positive	6/19/2024	Dining Room	Window 1	Exterior Jamb	Wood	D	Deteriorated
422 Locust Ave	128	0.2	mg/cm2	Negative	6/19/2024	Dining Room	Built-In	Door	Wood	C	Deteriorated
422 Locust Ave	129	0.1	mg/cm2	Negative	6/19/2024	Dining Room	Built-In	Shelf	Wood	C	Deteriorated
422 Locust Ave	130	0.1	mg/cm2	Negative	6/19/2024	Bathroom 1	Door	Casing	Wood	D	Deteriorated
422 Locust Ave	131	0.1	mg/cm2	Negative	6/19/2024	Bathroom 1	Door	Inner Casing	Wood	D	Deteriorated
422 Locust Ave	132	0.2	mg/cm2	Negative	6/19/2024	Bathroom 1	Door	Stop	Wood	D	Deteriorated
422 Locust Ave	133	0.1	mg/cm2	Negative	6/19/2024	Kitchen	Room	Wall	Wood	A	Deteriorated
422 Locust Ave	134	0.2	mg/cm2	Negative	6/19/2024	Kitchen	Room	Wall	Wood	B	Deteriorated

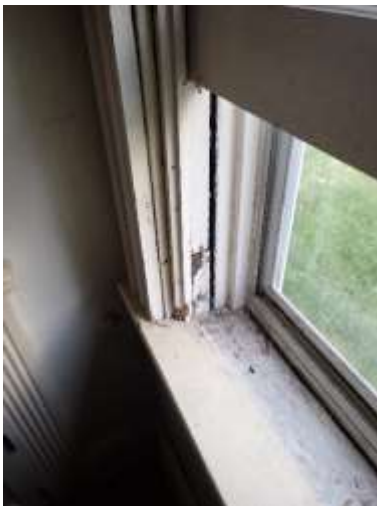
Shot # 127

127	1	D	Dining Room/ Window 1	Exterior Jamb	Wood	Deteriorated	Positive	32	4	Replace Window
141	1	N/A	Stairwell 1	Treads and Risers	Wood	Deteriorated	Positive	7.4	1	Enclosure
221	1	A	Front Porch/ Door	Inner Casing	Wood	Deteriorated	Positive	2.6	1	Stabilize and Encapsulate w/ 20 yr LBC
222	1	A	Front Porch/ Door	Header	Wood	Deteriorated	Positive	2.2	1	Stabilize and Encapsulate w/ 20 yr LBC
223	1	A	Front Porch/ Door	Threshold	Wood	Deteriorated	Positive	32	1	Strip to Bare Substrate and Encapsulate w/ 20 yr LBC
224	1	A	Front Porch/ Door	Header Trim	Wood	Deteriorated	Positive	35	1	Stabilize and Encapsulate w/ 20 yr LBC
225	1	B	Front Porch/ Beam	Side Face	Wood	Deteriorated	Positive	30	1	Stabilize and Encapsulate w/ 20 yr LBC
226	1	B	Front Porch/ Beam	Underside	Wood	Deteriorated	Positive	2.5	1	Stabilize and Encapsulate w/ 20 yr LBC
227	1	B	Front Porch	Ceiling	Wood	Deteriorated	Positive	32	1	Repair, Stabilize, and Encapsulate w/ 20 yr LBC

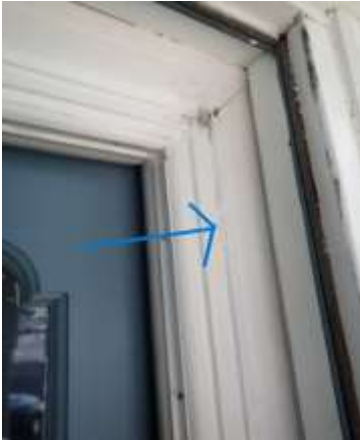
SHOT # 221

422 Locust Ave	219	0.4	mg/cm2	Negative	6/19/2024	Front Porch	Door	Casing	Wood	A	Deteriorated
422 Locust Ave	220	0	mg/cm2	Negative	6/19/2024	Front Porch	Door	Inner Casing	Wood	A	Deteriorated
422 Locust Ave	221	2.6	mg/cm2	Positive	6/19/2024	Front Porch	Door	Inner Casing	Wood	A	Deteriorated
422 Locust Ave	222	2.2	mg/cm2	Positive	6/19/2024	Front Porch	Door	Header	Wood	A	Deteriorated
422 Locust Ave	223	32	mg/cm2	Positive	6/19/2024	Front Porch	Door	Threshold	Wood	A	Deteriorated
422 Locust Ave	224	35	mg/cm2	Positive	6/19/2024	Front Porch	Door	Header Trim	Wood	A	Deteriorated
422 Locust Ave	225	30	mg/cm2	Positive	6/19/2024	Front Porch	Beam	Side Face	Wood	B	Deteriorated
422 Locust Ave	226	2.5	mg/cm2	Positive	6/19/2024	Front Porch	Beam	Underside	Wood	B	Deteriorated
422 Locust Ave	227	32	mg/cm2	Positive	6/19/2024	Front Porch	Room	Ceiling	Wood		Deteriorated
422 Locust Ave	228	0.2	mg/cm2	Negative	6/19/2024	Front Porch	Room	Floor	Wood		Deteriorated

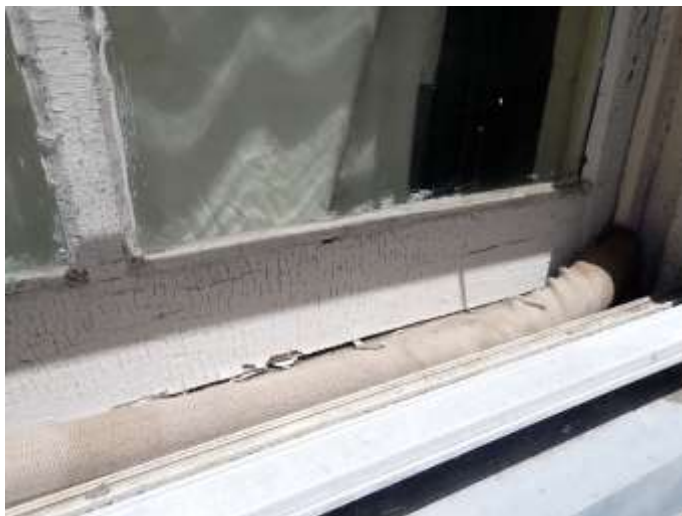
SHOT # 237

237	1	B	Exterior/ Window 3	Sash	Wood	Deteriorated	Positive	32	5	Replace Window
238	1	B	Exterior/ Window 3	Jamb	Wood	Deteriorated	Positive	37	5	Replace Window

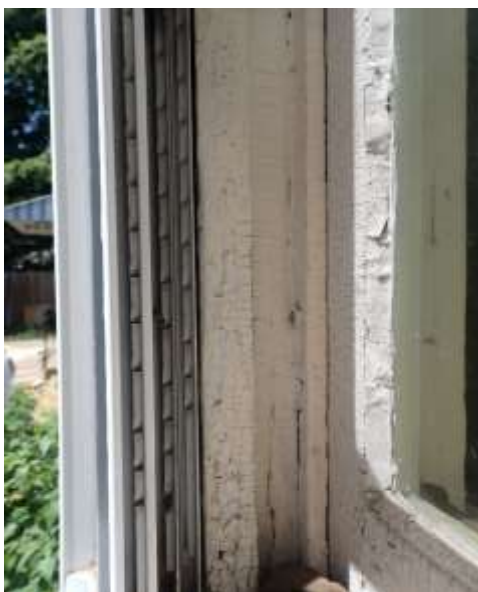
SHOT # 238

422 Locust Ave	229	0	mg/cm2	Negative	6/19/2024	Front Porch	Column		Wood	A	Deteriorated
422 Locust Ave	230	0.1	mg/cm2	Negative	6/19/2024	Front Porch	Railing		Wood	A	Deteriorated
422 Locust Ave	231	0.3	mg/cm2	Negative	6/19/2024	Front Porch	Railing		Metal	A	Deteriorated
422 Locust Ave	232	0.1	mg/cm2	Negative	6/19/2024	Front Porch	Lattice		Wood	A	Deteriorated
422 Locust Ave	233	0	mg/cm2	Negative	6/19/2024	Exterior	Door	Casing	Wood	B	Deteriorated
422 Locust Ave	234	0.2	mg/cm2	Negative	6/19/2024	Exterior	Door	Riser	Wood	B	Deteriorated
422 Locust Ave	235	0.1	mg/cm2	Negative	6/19/2024	Exterior	Door	Threshold	Wood	B	Deteriorated
422 Locust Ave	236	0.3	mg/cm2	Negative	6/19/2024	Exterior	Door	Awning	Metal	B	Deteriorated
422 Locust Ave	237	32	mg/cm2	Positive	6/19/2024	Exterior	Window 3	Exterior Sash	Wood	B	Deteriorated
422 Locust Ave	238	37	mg/cm2	Positive	6/19/2024	Exterior	Window 3	Exterior Jamb	Wood	B	Deteriorated
